Treating a Fracture Using Direct Resin

Accreditation Clinical Case Report, Case Type IV (Class IV Fracture)

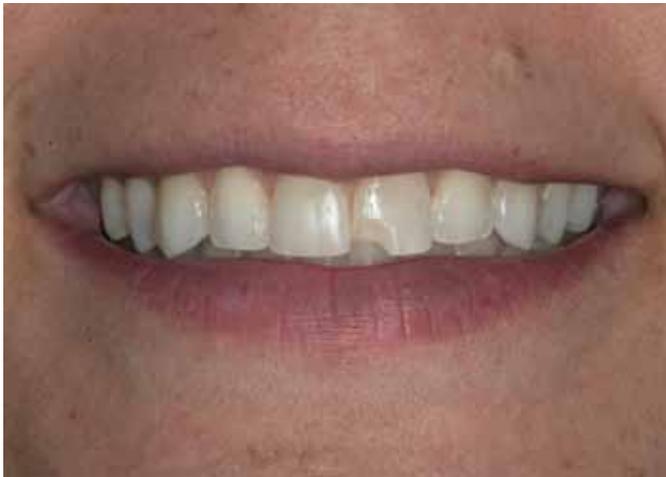
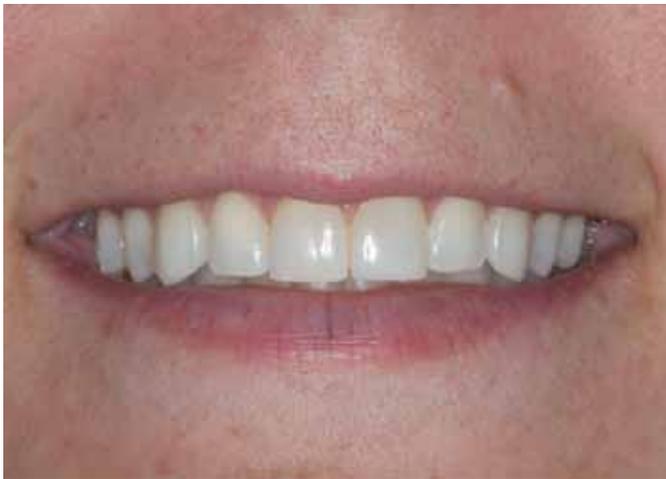
Figures 1a & 1b: Preoperative smile; fractured left central incisor resulting from a traumatic incident. Postoperative smile; restored left central incisor mimicking the color and translucency of the right central incisor.

The patient was a 29-year-old-female with no adverse medical history and in good overall health. She presented on an emergency basis after being involved in an incident that resulted in the fracture of tooth #9 (**Figs 1a & 1b**). Her chief complaint was that she needed to have her broken front tooth fixed immediately; the owner of a com-

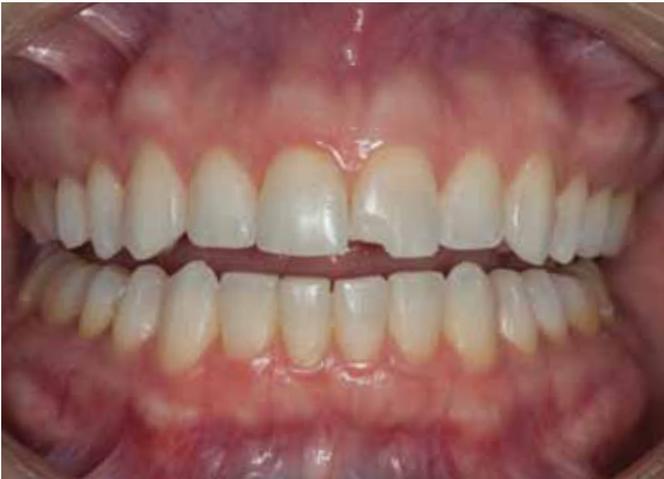
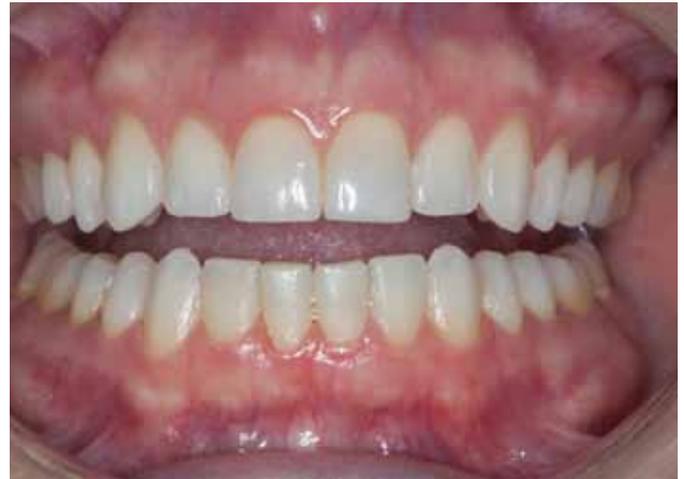
Figures 2a & 2b: Preoperative 1:2 view; visible horizontal fractured left central incisor. Postoperative 1:2 view; restored left central incisor matching the light reflective properties of #8.

An emergency examination was performed, and health history, diagnostic models, inter-occlusal registration, digital radiographs, and digital photographs were recorded.³ The patient's symptoms were fully reviewed and evaluated and all treatment options were discussed with her. The patient was also informed of the possibility of the need for endodontic management of the traumatized tooth, as well as the potential for discoloration of the remaining tooth structure. All the patient's questions were answered. The teeth were evaluated and checked for any possible fractures, pulp exposures, and mobility. A single visible fracture was observed progressing from the mesial one-third to the incisal one-half (Figs 2a & 2b). The balance of her anterior teeth appeared

As an examiner, one of the major factors to evaluate is whether the restoration "stands out" in the 2:1 postoperative photographs. In other words, the best restoration is one that you can't see! In this case the restoration blends nicely into the tooth, as shown in the 2:1 postoperative view.

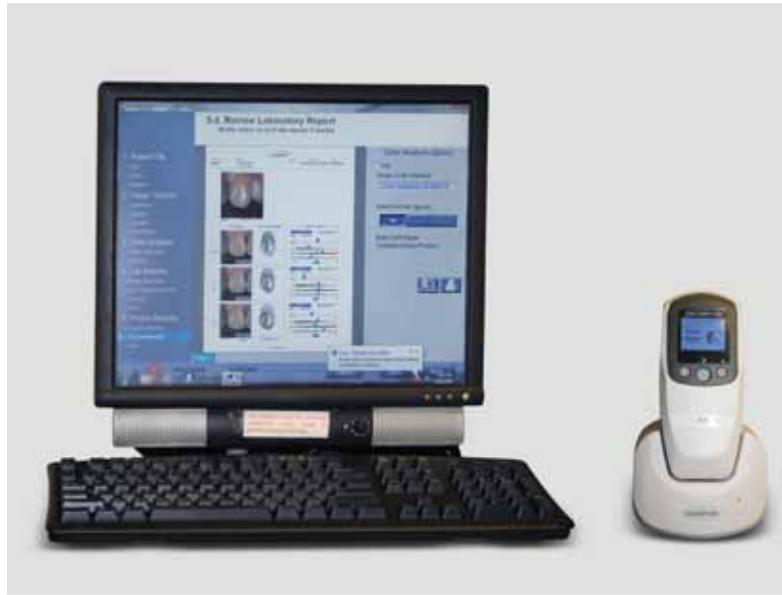
Figure 3: A Crystaleye Spectrophotometer was used to digitally color map the right central incisor. The information was transferred to computer software, analyzed, and used to assist in selecting composite materials with the correct color and translucency.

of the adjacent teeth (Fig 3). This provided valuable information in the selection of composite shades for the final direct resin. Further evaluation and vitality tests were done to ensure that the tooth did not require endodontic therapy.

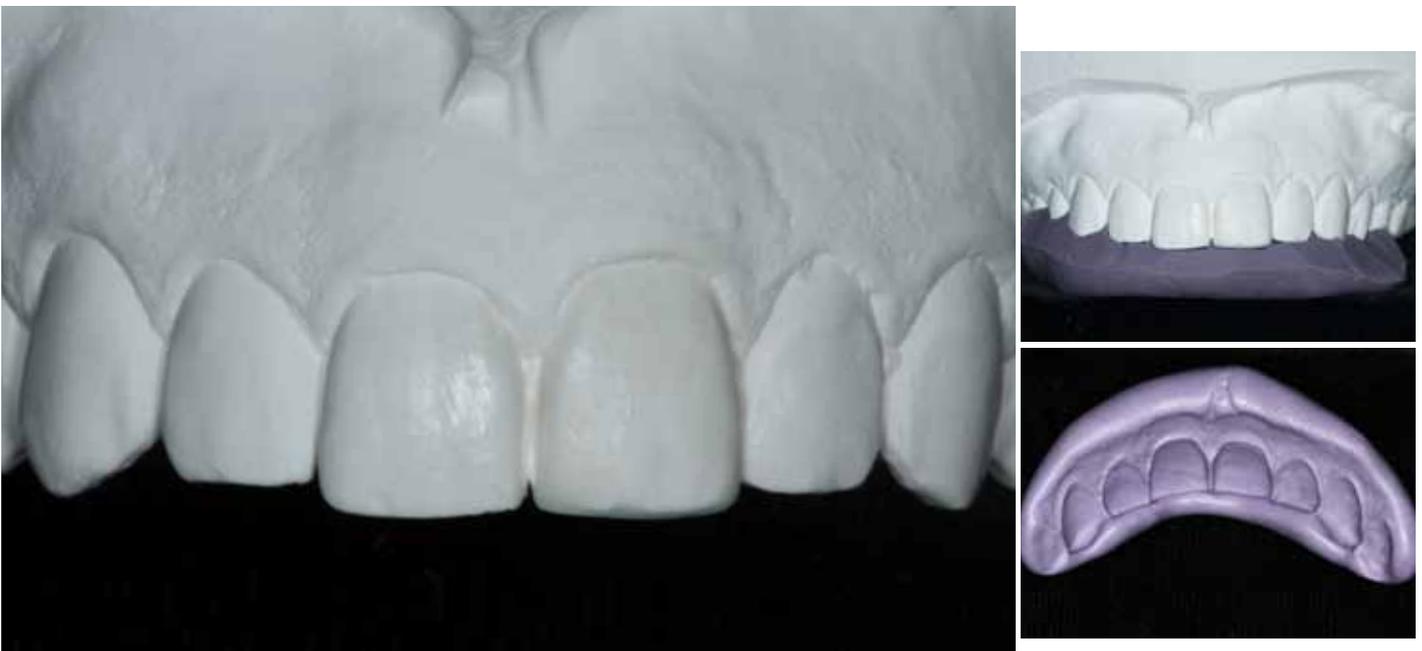
Figures 4a-4c: Diagnostic wax-up showing the proposed treatment plan (putty matrices for the definitive composite additions to the lingual and facial contours).

Two sets of silicone putty matrixes using Splash Putty (Discus Dental; Culver City, CA) were created from the diagnostic wax-up⁵ (Figs 4a-4c): one to replicate the intended lingual contours and the incisal edge for the first layer of hybrid composite, and the other as a guide for the facial portion of the tooth to help reproduce #8.⁶ A Crystaleye Spectrophotometer reading was taken on both #8 and #9 (Figs 5a & 5b) to help determine the appropriate shade of the final composite resin. A color mock-up was done in the patient's mouth to verify the composite "recipe" that would best mimic the colors of the adjacent intact central.⁷ Renamel (Cosmedent; Chicago, IL) shades incisal light A1 and B1 were selected.

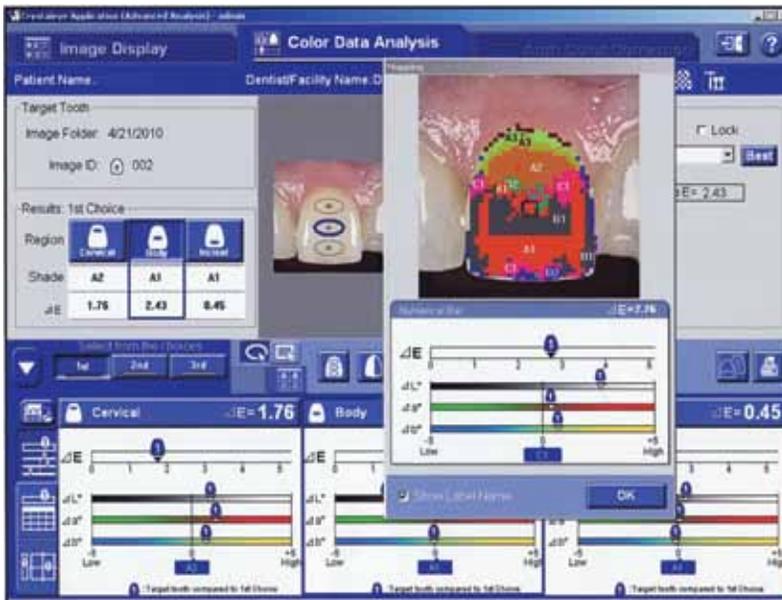
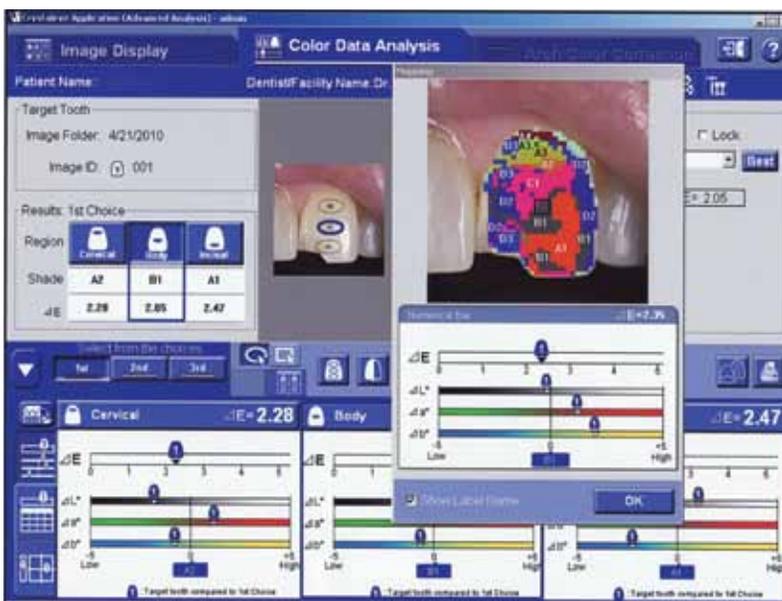
Figures 5a & 5b: A Crystaleye Spectrophotometer analysis on #8 showing the color mapping to be matched. An analysis was also done on #9 to compare it to #8.

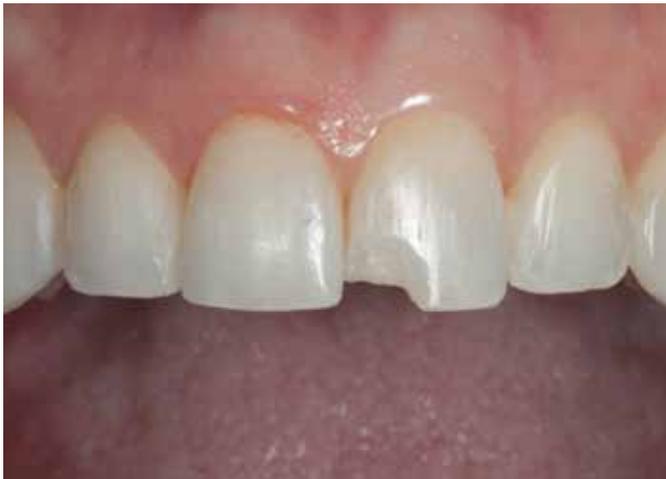
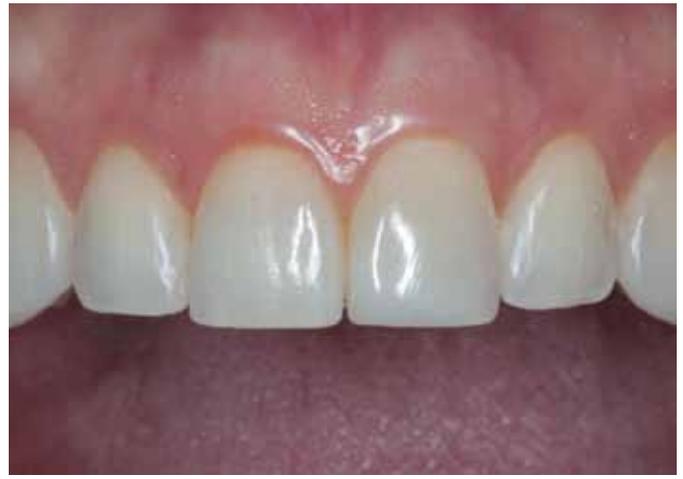
Figures 6a & 6b: Preoperative and postoperative 1:1 frontal images showing the esthetic result of the composite placement, finishing, and similar light-reflective properties.

contour, defining the mesial line angle, light-reflective properties, and contour. A pencil mark was placed on the mesial facial of the tooth to help visualize the height of contour of the mesial-facial line angle.⁸ Coarse and medium-grit FlexiDiscs (Cosmedent) and an ET9 bur (Brasseler USA; Savannah, GA) were then used to achieve final contour. No tints or opaquers were needed to achieve the best possible esthetics in this case.

The restoration was then taken to final finish and polish with FlexiPoints,

FlexiCups, FlexiBuffs, and Enamelize (Cosmedent) (Figs 6a & 6b).⁹ Occlusion was adjusted and postoperative instructions—including oral hygiene directions—were given to the patient. A two-week postoperative appointment was made to check tissue health. Final digital photographs were taken several weeks after the final restoration was placed (Figs 7a & 7b).

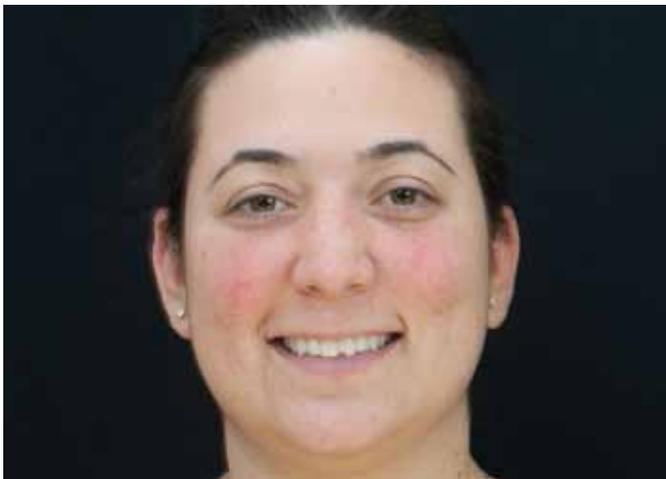
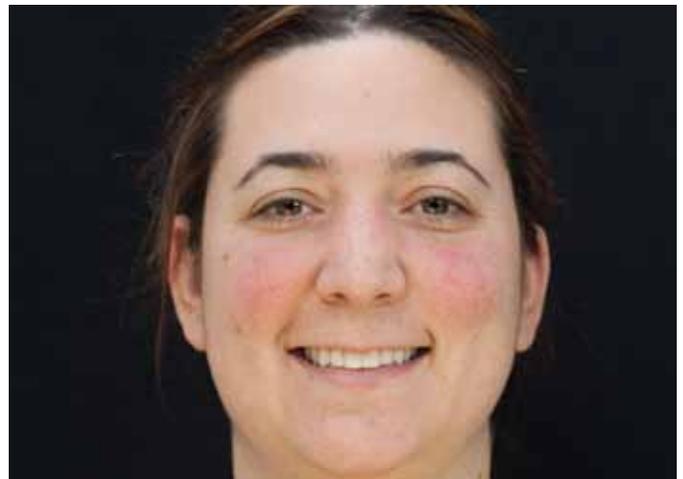
Figures 7a & 7b: Preoperative and postoperative full-face images, showing the final case after bleaching and direct Class IV resin placed.
