Class IV Composite Repair

A Heavily Textured Central Incisor

Robert L. Strain, DDS

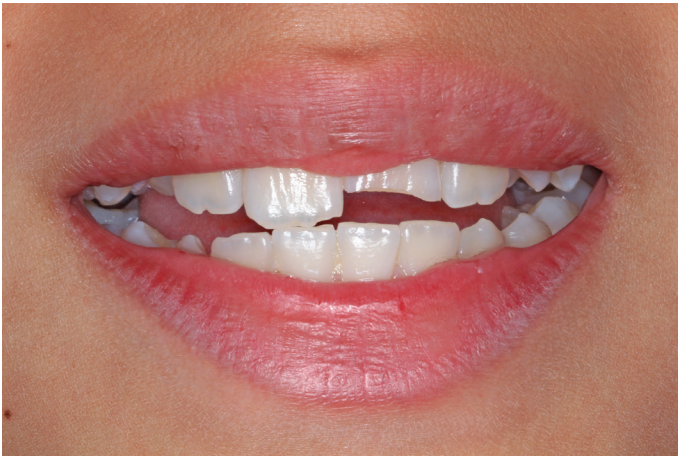
Figure 1a: The “before” smile view shows the large fracture of tooth #9.

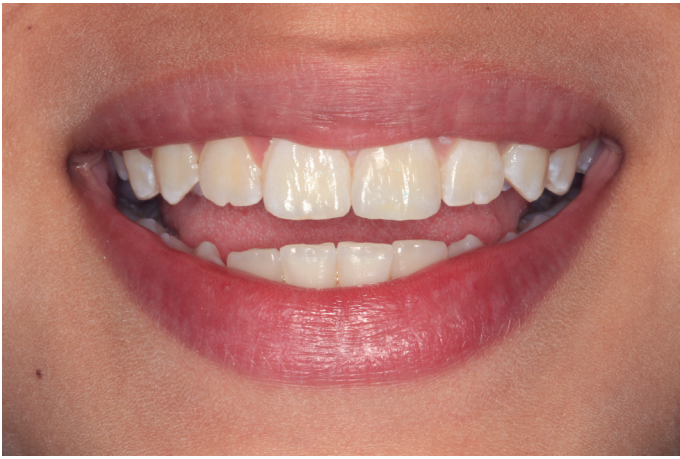
Figure 1b: The “after” smile view shows a natural, polychromatic, and esthetic result.

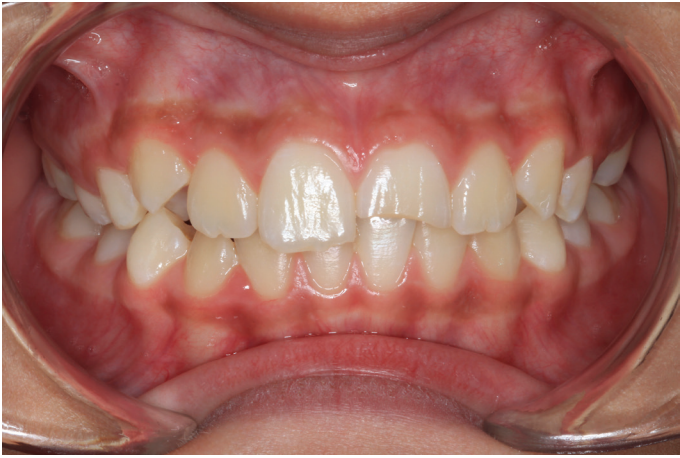
Figure 2a: The 1:2 retracted preoperative view.

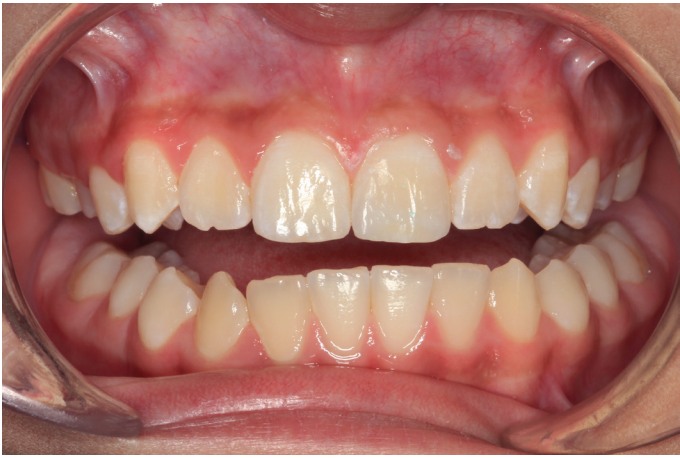
Figure 2b: The 1:2 retracted postoperative view.

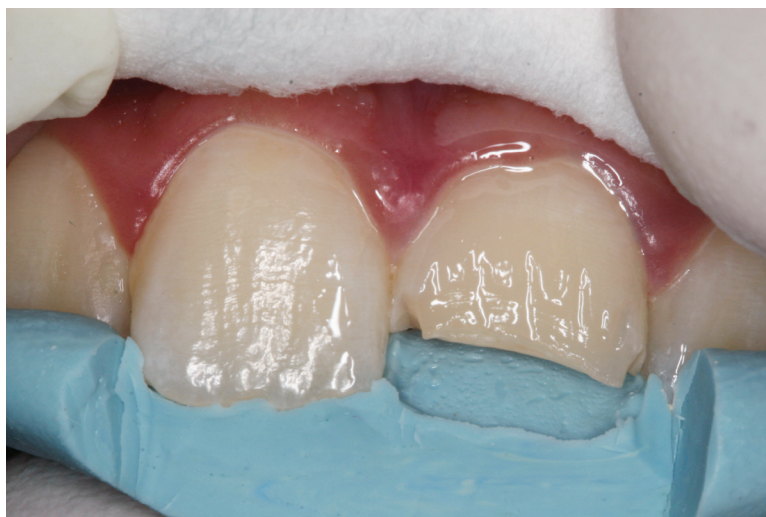
Figure 3: The putty matrix in place, displaying the random feathered bevels to mask the finish line. Bonding resin has been applied.

A diagnostic wax-up for #9 was developed (based upon the initial treatment plan) and a polyvinyl silane (PVS) (Exafast; GC America; Alsip, IL) matrix⁴ was made from this model prior to the treatment appointment (Fig 3).

A 2-mm shoulder preparation with a .5-mm depth was placed beyond the fracture line on #9 with a 856L-016 diamond bur (Henry Schein; Melville, NY). A 1-mm bevel was placed on the shoulder. Then a series of irregular feathered bevels was placed randomly on the facial surface.

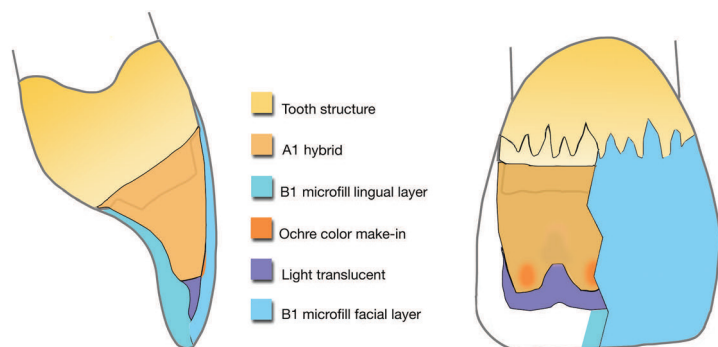
Figure 4: The color maps show the layers of composite used in the restoration. The frontal view shows a cutaway portion and the surface layer.

Reference to the color maps (Fig 4) can help in understanding the incremental build,^{5,6} as follows:

1. The internal dentin mamelons were reestablished with A-1 hybrid composite (Venus, Heraeus Kulzer; South Bend, IN), taking care to overlap the fracture line with the composite. Three individual lobes were developed and light-cured to mimic natural teeth and the adjacent central incisor. A hybrid composite was chosen because of its distinct benefit over microfill composites due to its ability to mask sharp edges, preventing the dark background of the mouth from revealing the fracture line.

2. The PVS matrix was placed and a very thin shell was built for the lingual wall in light translucent microfill composite (Renamel, Cosmedent; Chicago, IL).

3. The facial surface was built up in stages, beginning with the most gingival area, using B1 microfill composite (Renamel). Small depressions were left near the incisal to be filled with very minimal ochre chroma (Kolor + Plus, Kerr; Orange, CA) covered by light translucent microfill composite (Renamel).⁷ Because of the tooth's high texture, the outer surface texture was modified to an irregular, non-worn texture using the tip of a #2 flat sable brush (Loew-Cornell; Erlanger, NY) just prior to curing. The translucent nature of these microfill resins allow the dentin layers to show through, creating excellent blending and high polishability.

4. The mesial and distal contacts on #9 were developed with B-1 microfill utilizing clear plastic matrix strips (Henry Schein) separating the tooth from adjacent teeth.

5. The resulting buildup appeared too low in value, so the lingual wall and some of the translucent composite were then replaced with white enamel-colored resin composite (Renamel). This change blocked the dark background show-through and provided the desired result.

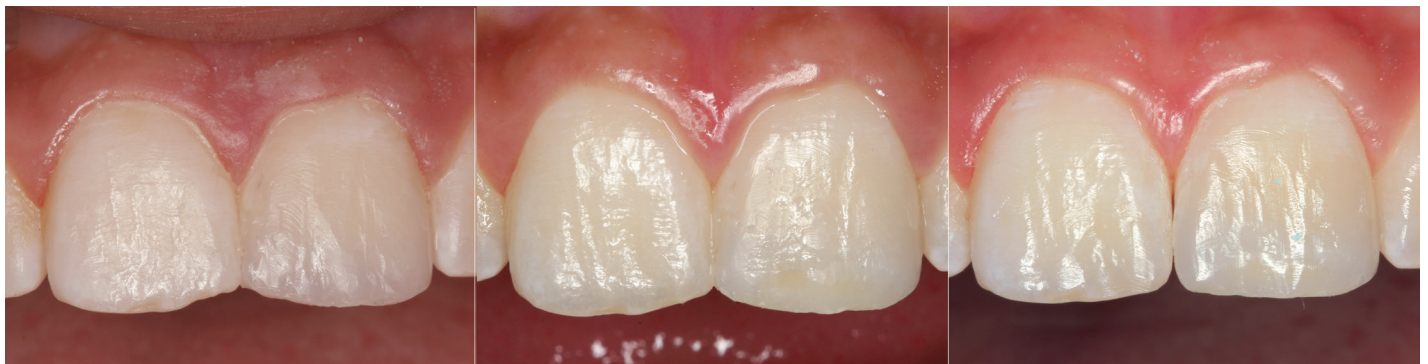
Despite an excellent match to tooth #8, after reviewing the postoperative photos, it was determined that the patient would benefit even more if the mesial incisal corners of both #8 and #9 were restored to more ideal tooth form in accordance with Accreditation criteria.¹ This would allow for a more attractive incisal embrasure. Also, there was slightly too much ochre chroma. There was a bit of excessive flash past the mesial margin.

Figure 5: Side-by-side comparison showing the initial result compared to intermediate completion and the final restoration where #8 also has a small composite repair on the mesial incisal.

A simple irregular bevel was placed on the mesial incisal of both teeth. An area of excess chroma was removed with the blunt end of a diamond. The areas were restored with B1 microfill composite (Renamel) bonded with bonding resin (only). The gingival mesial margin was trimmed with a #12B surgical blade (Henry Schein) and smoothed with a fine-grit sandpaper strip (Sof-Lex).

The patient was rescheduled to return the following week and a new set of final AACD Accreditation photographs were taken. The stages to achieve the final restoration are compared in Figure 5.

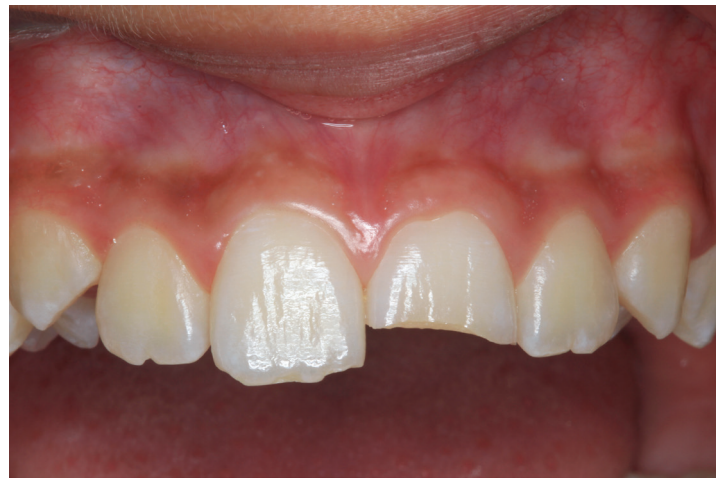
Figure 6a: The large Class IV fracture as seen on a 1:1 view.

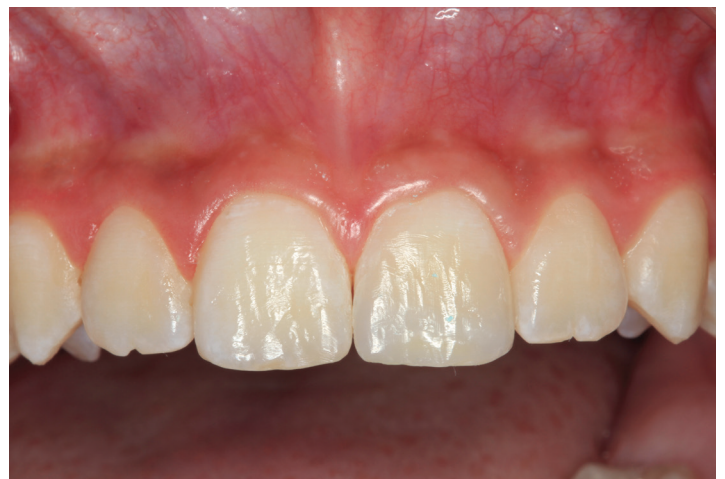
Figure 6b: The 1:1 postoperative image shows the intricate surface texture that had to be duplicated.

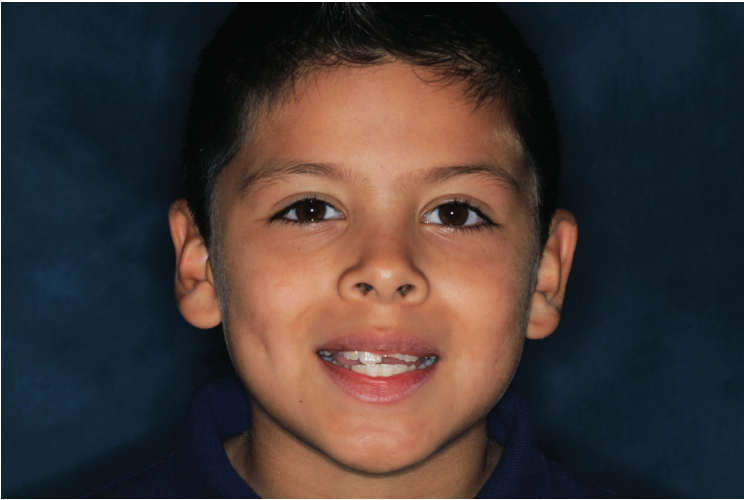
Figure 7a: Full-face preoperative view; the large fracture is clearly visible.

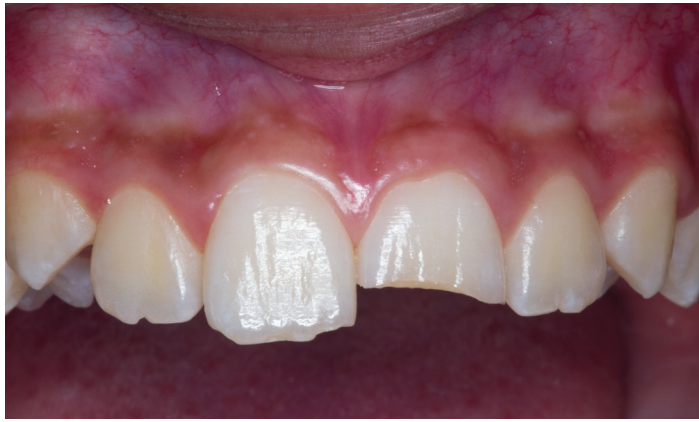
Figure 1: Classic incisal fracture.

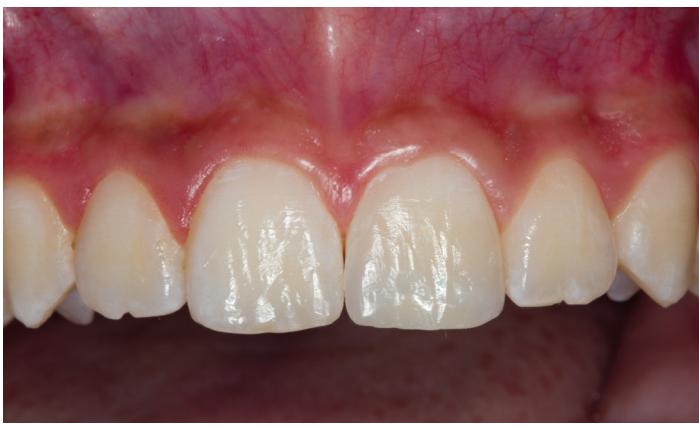
Figure 2: Microesthetics: Note the blending of the shading and texture of the resin.

and microfill composites to combine strength and enamel replication.² Using a long, irregular bevel to create a gradual transition from sound tooth structure to the restoration, he did a good job overcoming the “glass effect,” a graying at the margin that can occur when blending composite over a bevel.³
