Time-Saving Techniques for **COMMON EMERGENCIES**

Class IV Direct Resin “Pearls”

Kevin M. Brown, DDS, AAACD

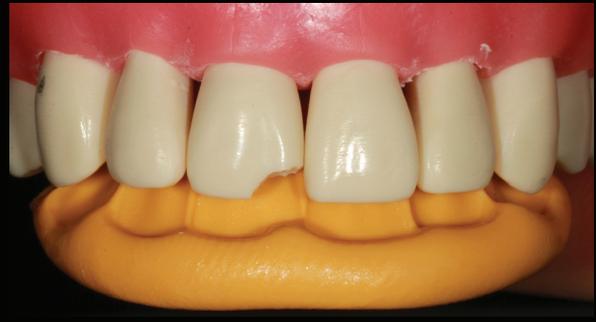
Figure 1: Silicone index of maxillary anterior segment including the fractured tooth.

Most of the fractured front tooth emergencies the author sees occur in children and adolescents as the result of an accident. When fitting in such patients on a last-minute basis, there often is not time to do a direct or indirect mock-up. Therefore, a silicone index (Panasil Fast Set Putty, Kettenbach LP; Hauppauge, NY) of the whole maxillary anterior segment is taken first (Fig 1). If necessary, a hygienist can administer anesthesia while the author modifies the index in the laboratory. However, if the fracture is small enough, this often is not required.

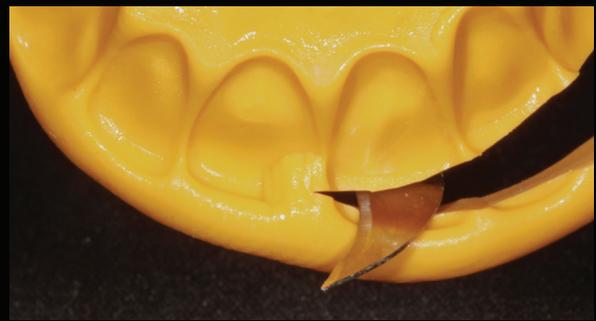
Figure 2: Trim the index with a surgical blade along the incisal edge.

A disposable #12 blade (Miltex; York, PA) is used to trim excess putty off the incisal edge to give a clean and clear edge to the facial incisal line angles (Fig 2). A laboratory carbide bur is then employed in a straight electric handpiece to trim away the excess material on the area of the fractured tooth (Fig 3). The idea is to visually assess the contour of the lingual surface and try to get an incisal embrasure and contact area (Fig 4). Various laboratory burs can be equally effective for this (a larger size is best for getting a smooth lingual surface, while a smaller size is better for refining the incisal embrasure and contact area). Since this is going to be used to establish the lingual shelf, it does not need to be perfect; it just needs to be good enough to lay the initial foundation, which can easily be modified once the lingual shelf is bonded in place. It should take only a minute to modify the silicone index. The author calls this the "emergency putty technique" (EPT). The following cases describe use of the technique in a variety of emergency situations.

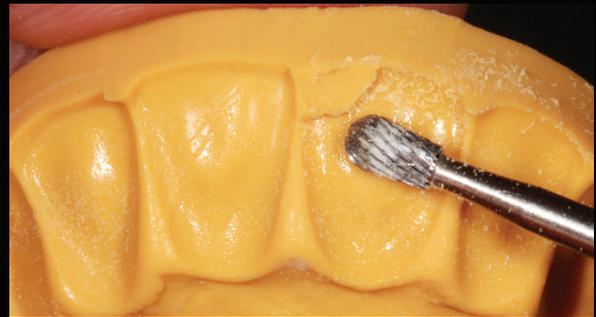
Figure 3: Use a round-ended carbide laboratory bur to modify the silicone index on the fractured tooth.

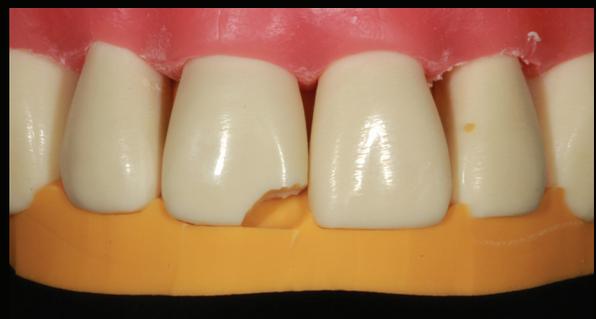
Figure 4: Try-in of silicone index to verify fit.

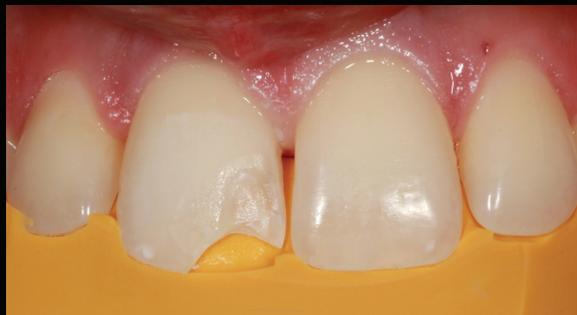
Figure 7: Try-in of modified silicone index to verify fit.

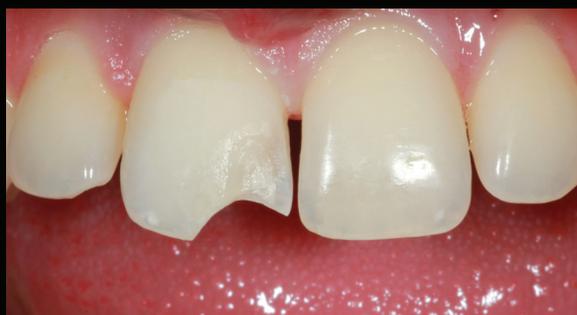
Figure 8: Tooth #8 prepared with long bevel and air abrasion.

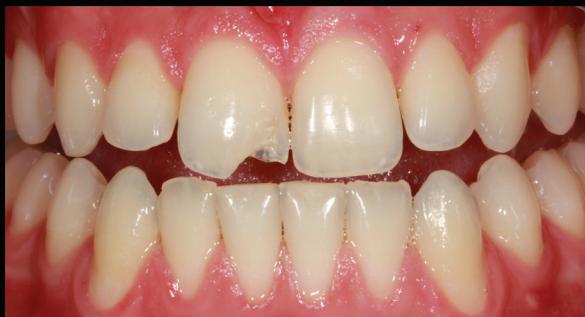
Figure 5: Fractured #8, 1:2 front retracted view.

A male college student had injured tooth #8 in a physical altercation (Figs 5 & 6). He reported that the tooth did not hurt and had only mild sensitivity to cold. After an x-ray and evaluation of the entire upper anterior area and temporomandibular joints determined that there were no other traumatic injuries, the EPT was fabricated as previously described. Minimal preparation of the enamel was completed by beveling the cavosurface margin and lightly abrading the enamel with an intraoral air microabrasion unit (MicroEtcher II; Danville Materials; San Ramon, CA) (Figs 7 & 8).³ Isolation was achieved using an OptraGate retractor (Ivoclar Vivadent; Amherst, NY) and the standard total-etch bonding protocol was followed (OptiBond Solo Plus, Kerr; Orange, CA) (Figs 9 & 10).⁴ Once the lingual shelf was formed (Fig 11), the subsequent layering of chromatic and achromatic colors was simple (Figs 12-17).^{5, 6}

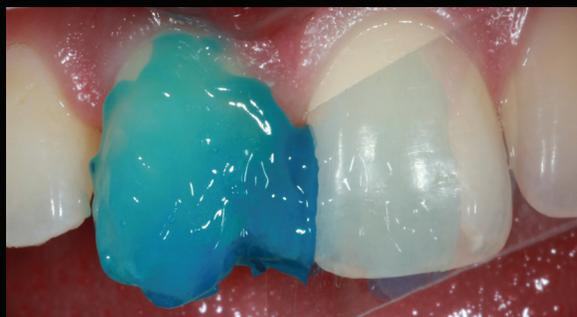
Figure 9: Phosphoric acid etch.

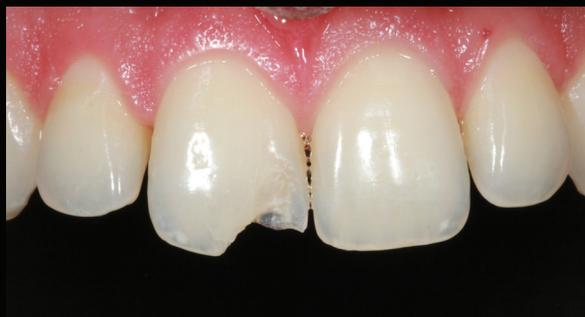
Figure 6: Fractured #8, 1:1 front retracted view.

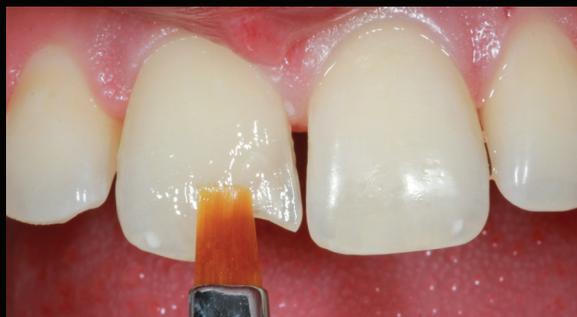
Figure 10: Total-etch bonding.

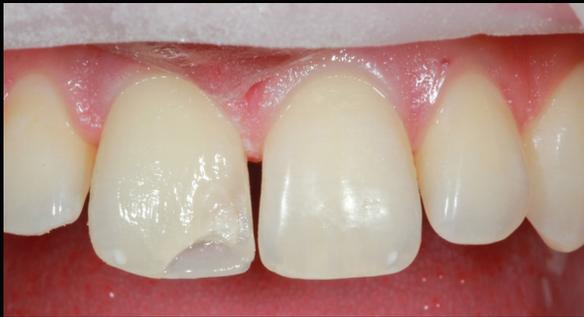
Figure 11: Lingual shelf in place using shade WE.

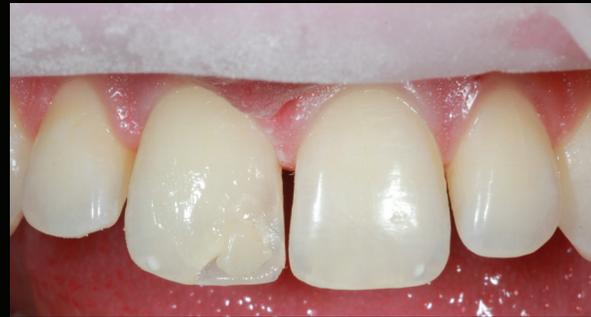
Figure 12: Ball of dentin shade DA2 to show color match with natural dentin before sculpting.

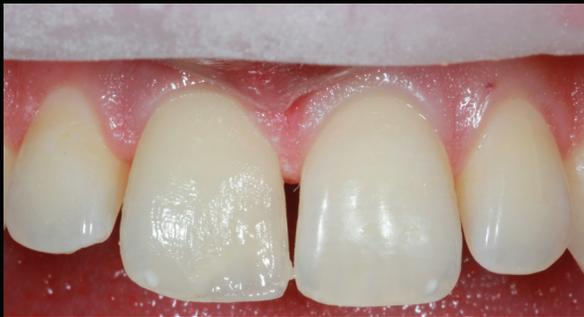
Figure 13: Dentin layer in place. The fracture line is still visible so a little more was added.

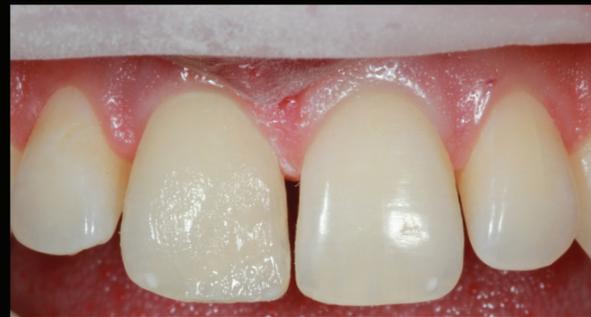
Figure 14: A thin layer of enamel shade EA2 in addition to a bleach shade BL1 used on the incisal tip to subtly accentuate the halo effect.

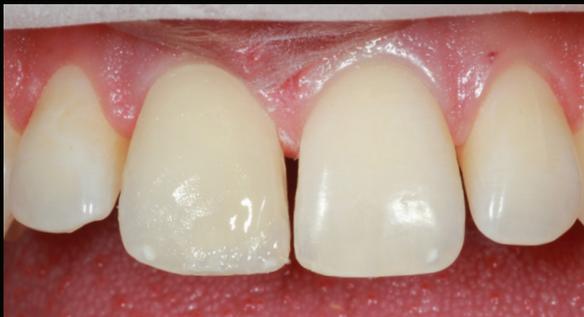
Figure 15: Thin layer of translucent shade TRANS on incisal tip and mesial edge.

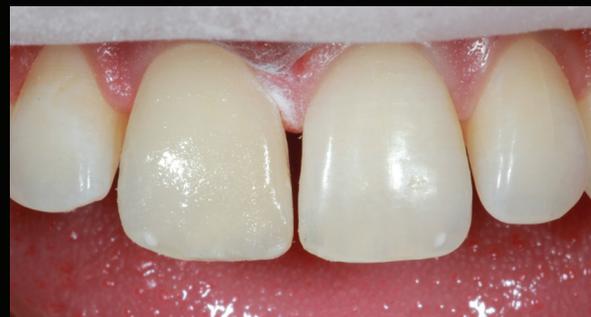
Figure 16: Enamel shade EA1.

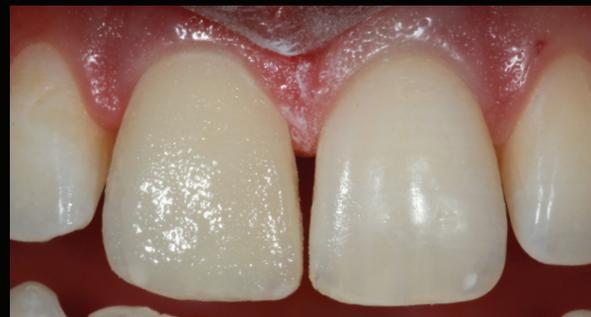
Figure 17: Final thin top layer of MW over entire facial surface.

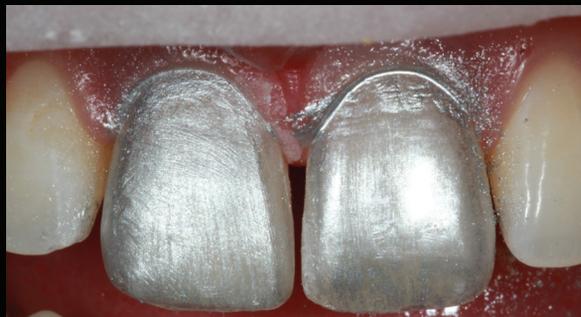
Figure 19: Reflective powder to evaluate initial line angles and reflective zones.

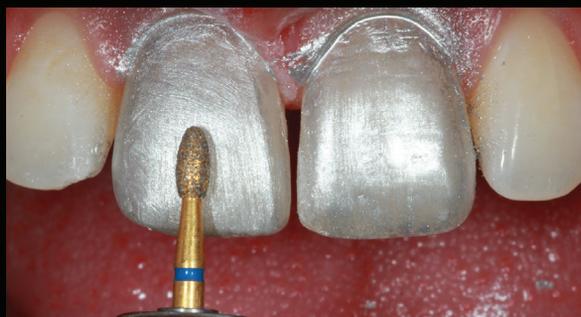
Figure 20: Coarse diamond to initiate secondary anatomy.

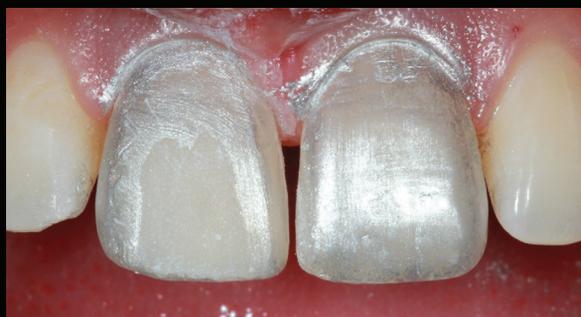
Figure 21: Evaluation of lobe formation.

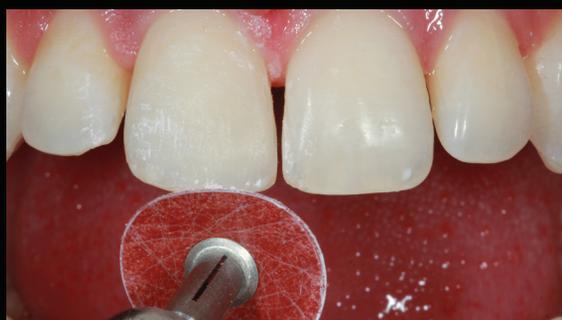
Figure 18: Initial contouring with a coarse disk.

The common protocol of using a variety of diamond and carbide burs and disks was followed to finish and polish the restoration⁷⁻¹⁰. A slow-speed handpiece was employed for better control and tactile sensation. A coarse Sof-Lex disk (3M ESPE; St. Paul, MN) was used to get the initial line angles and smooth the interface between the composite and enamel (Fig 18). A reflective powder was then dusted on to help visualize the reflective and non-reflective zones and clearly see the secondary and tertiary anatomy of #9, to which #8 was to be matched (Fig 19). A medium- or coarse-grit diamond bur (Axis Dental; Coppell, TX) was utilized to subtly form the vertical aspects of the lobes and grooves (Figs 20 & 21). Because the patient had fairly smooth enamel, a flame-shaped fine-grit diamond and round-tipped carbide bur (Axis) were used to refine the lobes and line angles (Figs 22 & 23). A reapplication of the reflective powder was helpful in visualizing the progress before the final polish (Fig 24). Once the author was satisfied with the secondary and tertiary anatomy, final polishing was accomplished with rubber wheels, a PDQ diamond brush (Axis), and Enamelize paste with a felt disk (Cosmedent; Chicago, IL) (Figs 25-27). A final dusting of the reflective powder confirmed that the composite blended in seamlessly and matched well to #9 (Fig 28). Figures 29 and 30 show the final result.

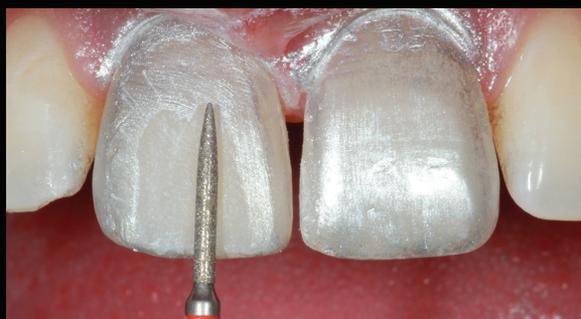
Figure 22: Fine-grit flame diamond to further develop and smooth lobes and line angles.

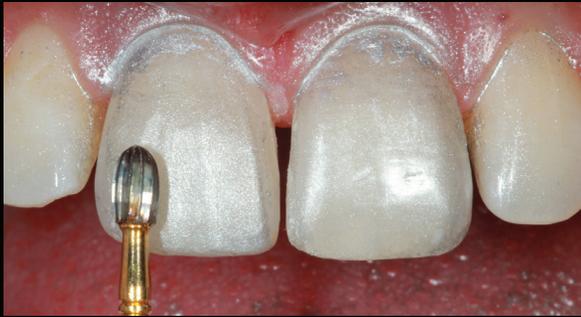
Figure 23: Round carbide bur to replicate surface texture and refine lobes and line angles.

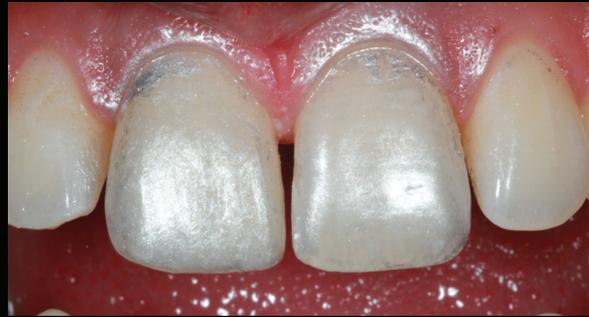
Figure 24: Reapplication of reflective powder to evaluate progress.

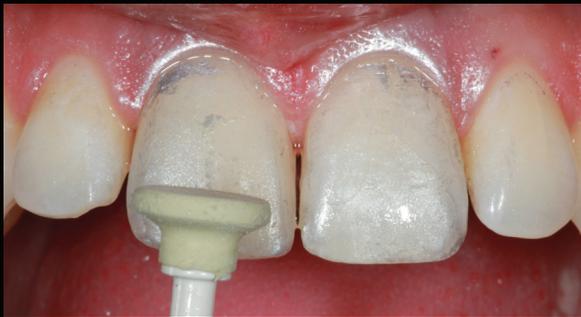
Figure 25: Rubber polishing wheel to smooth surface.

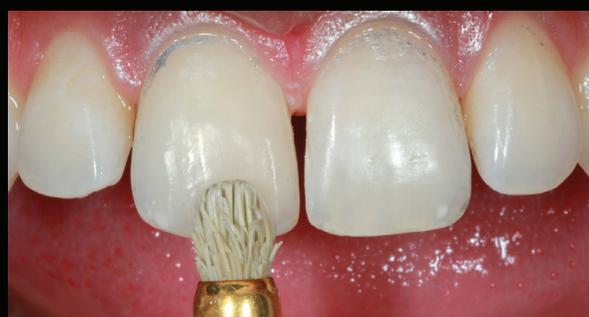
Figure 26: Diamond brush to shine surface without removing surface texture.

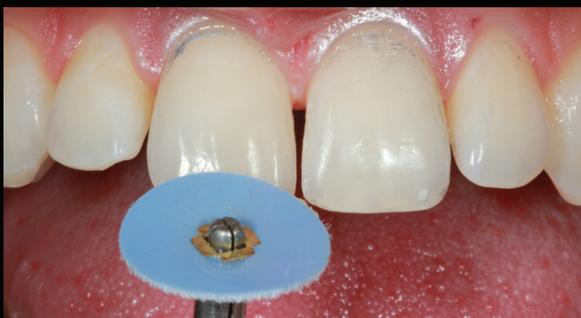
Figure 27: Polishing paste and felt disk for final polish.

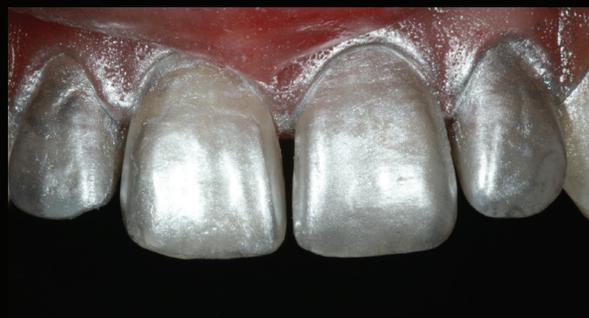
Figure 28: Final coat of reflective powder to verify secondary and tertiary anatomy and texture.

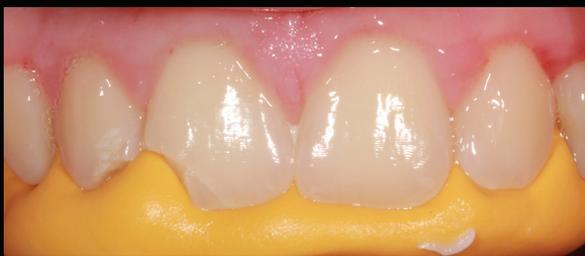
Figure 33: Silicone index of maxillary anterior segment including fractured teeth.

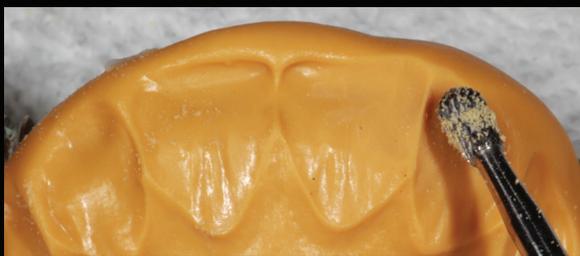
Figure 34: Modification of the silicone index to create lingual shelf.

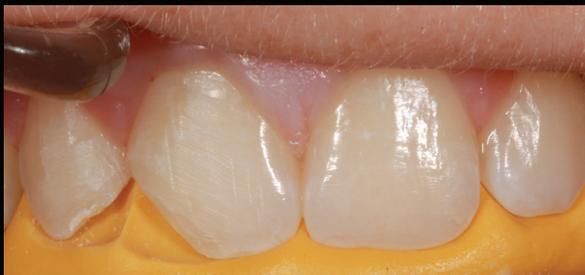
Figure 35: Try-in of modified index to verify fit.

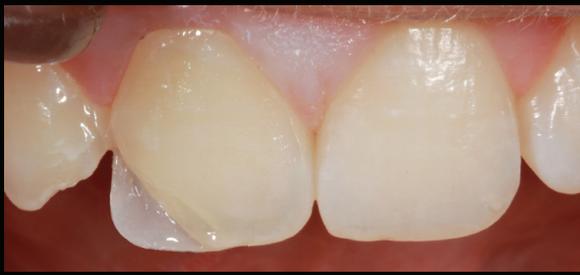
Figure 36: Lingual shelf established using shade WE.

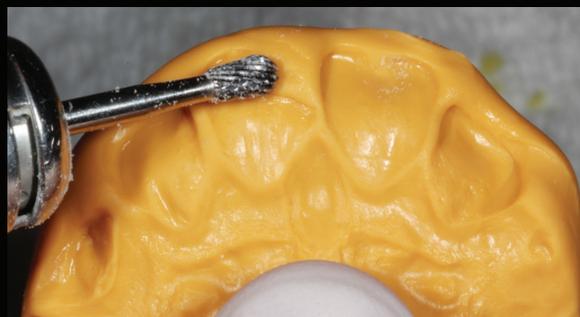
Figure 41: Modification of silicone index.

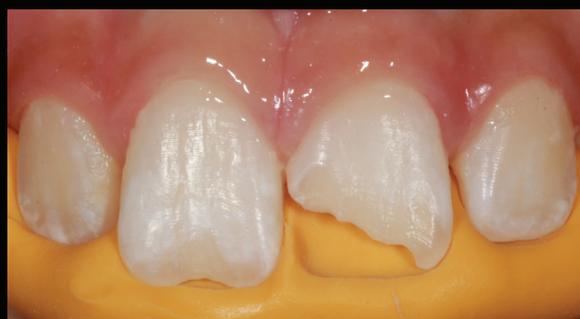
Figure 42: Try-in of modified index to verify fit.

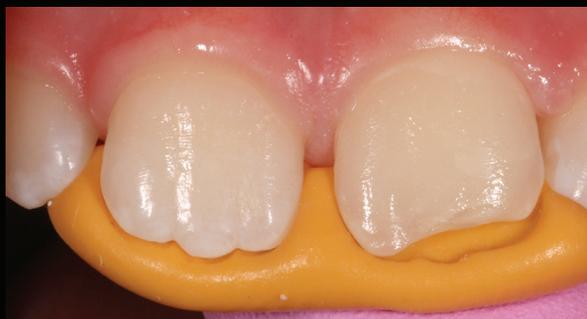
Figure 47: Try-in of modified silicone index to verify fit.

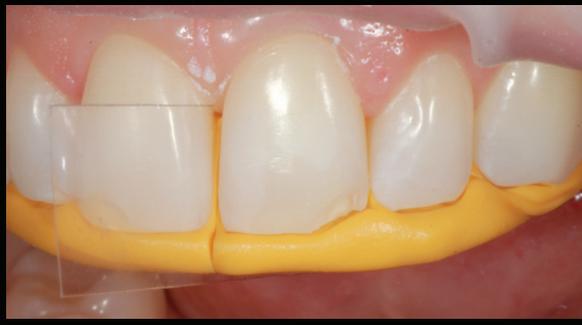
Figure 55: Try-in of silicone index with Mylar strip.

To accomplish this technique a silicone index is required. In this specific example it was done in conjunction with the EPT so the silicone index was already made. A disposable #12 blade was used to carefully cut straight down the midline in the silicone index (it is much easier to make a smooth straight slice if the index is not too thick). Once the slice was made it was tried in the patient's mouth to verify that the Mylar would fit all the way to the level of the gingival. Adjustments were made until it fit well (Fig 55).

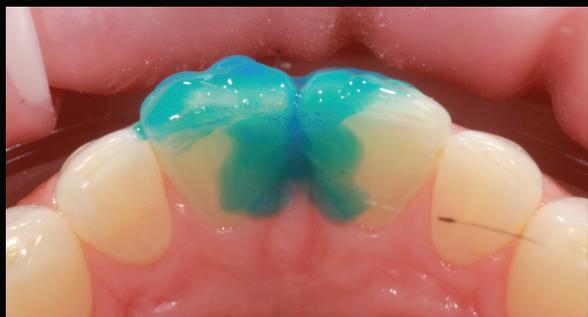
Figure 56: Phosphoric acid etch for diastema extending onto palatal surface.

When restoring a diastema, it is important that the palatal enamel is also cleaned and etched to allow for a smooth transition of the composite from labial to palatal (Fig 56). Once the enamel was ready for the composite a small rope of MW composite (Estelite Omega Composite System, Tokuyama Dental; Tokyo, Japan) was placed on the mesiopalatal line angles of #8 and #9 within the silicone index with the Mylar in place (Fig 57). The silicone index was then placed in the mouth and pressed labially with enough pressure to ensure proper fit and to express excess composite labially through the diastema (Fig 58).

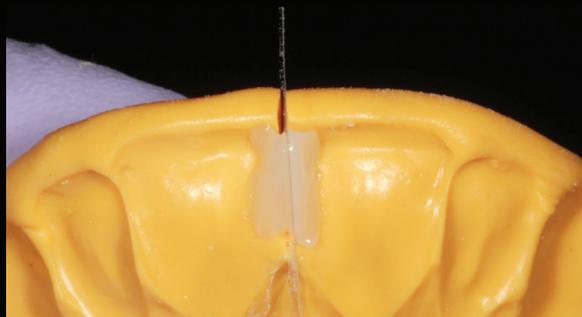
Figure 57: Thin layer of shade MW on mesiolingual line angle of silicone index with Mylar in place to maintain contact area.

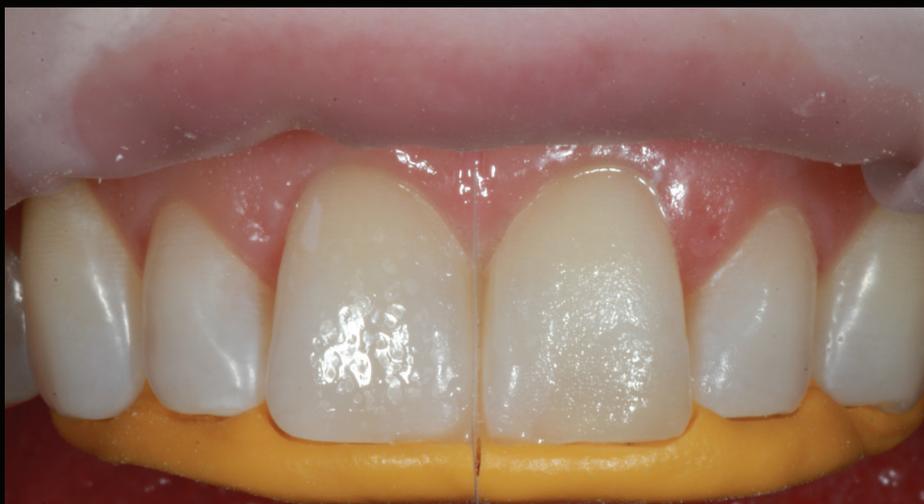
Figure 58: Excess composite expressed labially with Mylar in position.

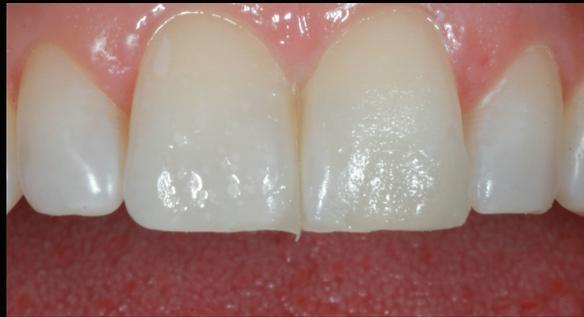
Figure 59: The Mylar was removed after the composite was light-cured.

With the Mylar strip in place, the contact point was maintained. A composite spatula was used to remove excess composite to the midfacial point and also to contour the gingival emergence of the composite (Fig 59). This layer acts in a similar way to the lingual shelf of a Class IV restoration. With the Mylar still in place, a small layer of EB1 (Tokuyama) was added to prevent the interproximal area from being overly translucent (Fig 60). A final thin layer of MW was placed and feathered into the mesiofacial for the final contour using a sable brush. The facial and palatal gingival embrasures were refined with a #12 blade and the contact area was smoothed with medium- and fine-grit interproximal reduction strips (Axis) (Figs 61 & 62).

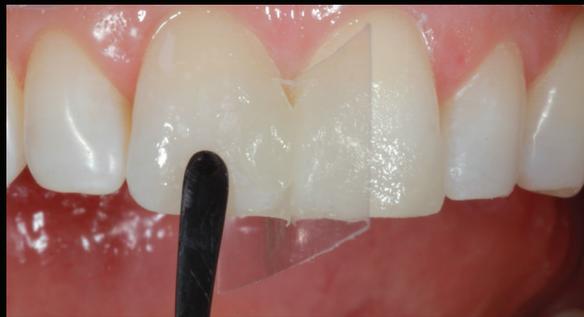
Figure 60: With the Mylar back in place, the final layers of composite were placed and contoured.

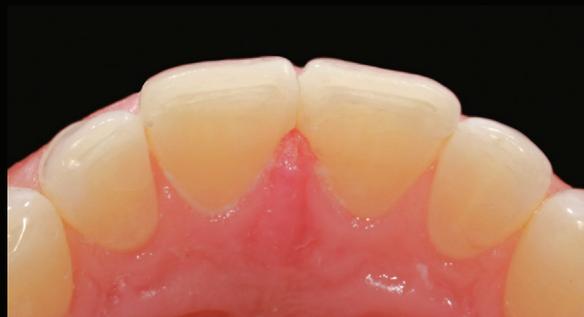
Figure 62: Palatal contour and embrasure form, 1:1 incisal view.
