A Systematic Approach to the Class IV Restoration

Camille J. Zelen, DDS

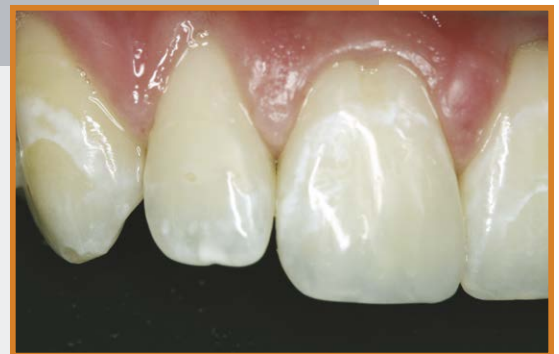
// Shade mapping provides a predictable roadmap for layering the composite to achieve lifelike esthetics that blend seamlessly into the dentition. //

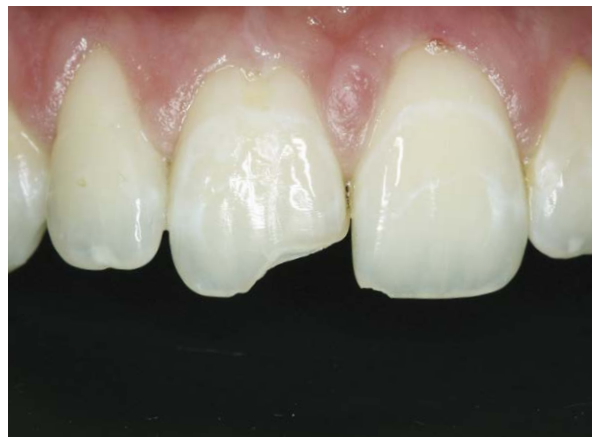
Figure 1: The preoperative retracted anterior view (1:1) shows the incisal corner fractures of #8 and #9.

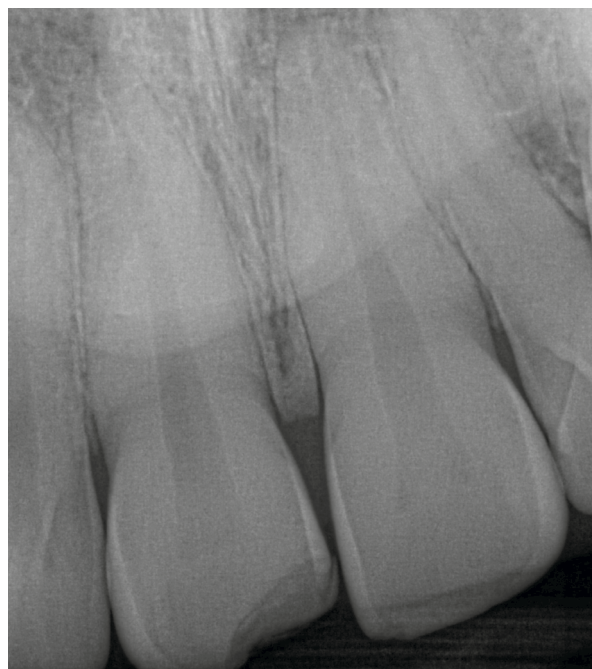
Figure 2: A preoperative periapical x ray ruled out pulpal involvement or pathology.

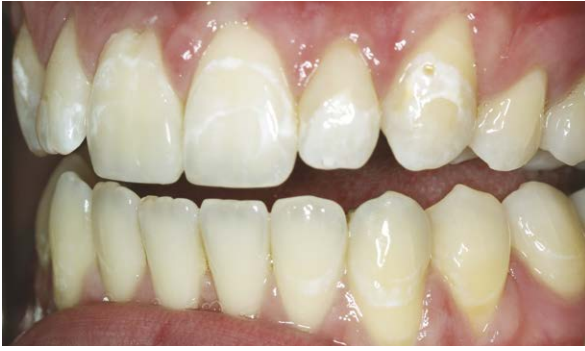
Figure 3: The postoperative retracted left lateral view (1:2) shows the recreation of the incisal halo, which blends seamlessly into the intact tooth structure on the central incisors.

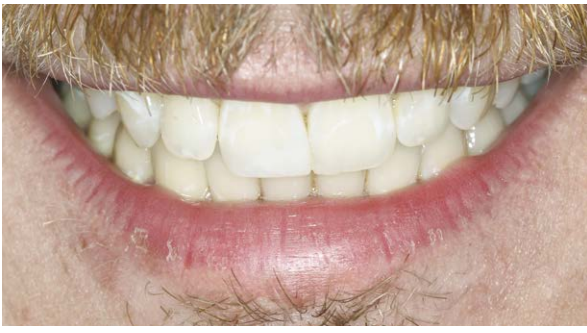
Figure 6: Postoperative smile, frontal view (1:2); the opacity was too noticeable and unnatural looking.
